Case Study

Keeping an efficient water flow in the mines, Portugal

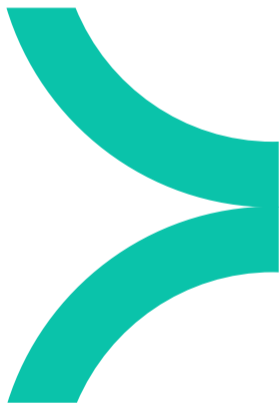
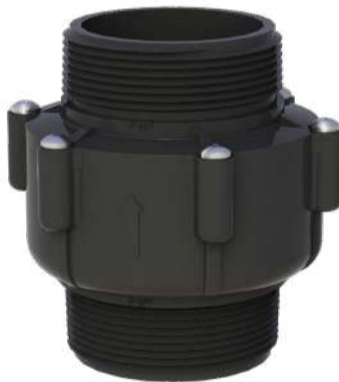
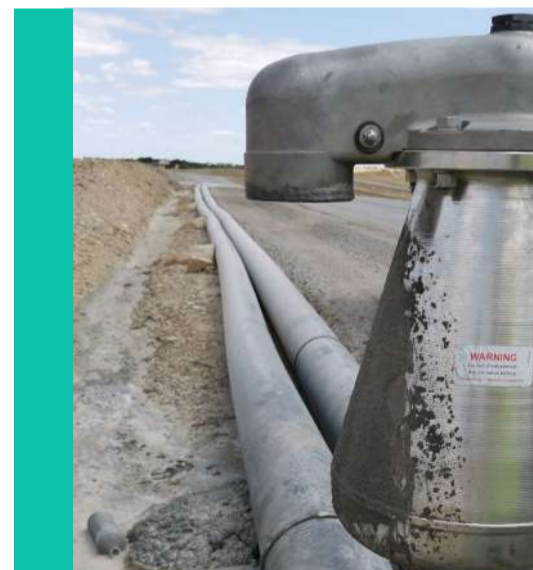
The water flow is inefficient because the air valves that fitted to the mines (model A.R.I. D-26 in diameter 3", made of stainless steel) and the taps on the line are blocked by the sediment.

The concrete also crystallized on the gaskets and caused the valve to leak.

Aquestia's engineers believed that cleaning the line components from sediment and creating air pockets inside the valve to prevent the liquid from entering the sealing area by turning the air valves installed in the system into vacuum vents by changing the mechanism of the installed valve.

After a period of system operation, there was a considerable improvement in the function of the valves and no complaints were received about blockages and leaks.

The system's designers recommend continuing to implement the change in the field and maintain a routine maintenance regime.
