Wessex Water Case Study

Aquestia's predictive smart water air valve, ARISENSE, detects issues before they occur.

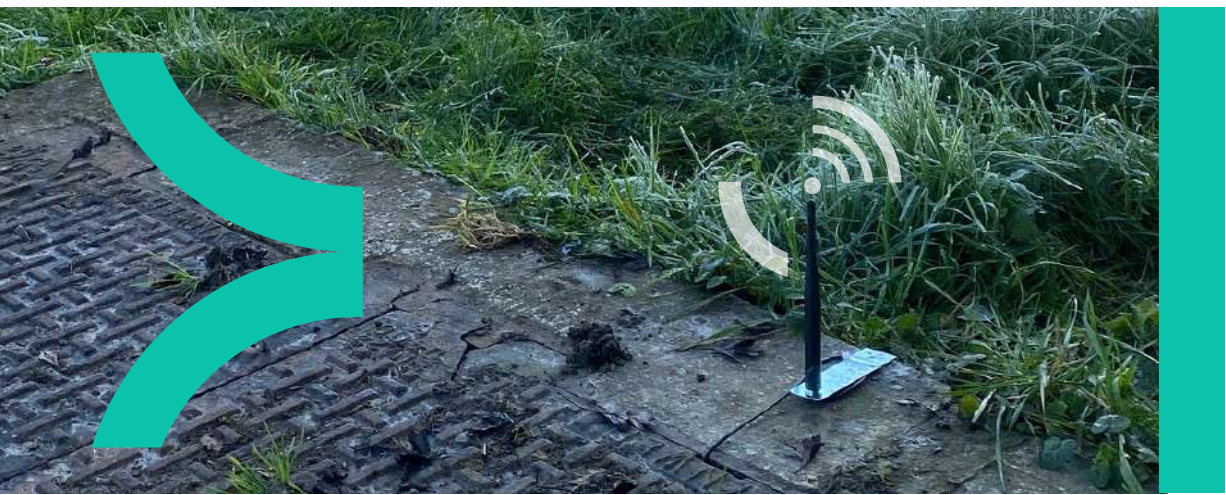
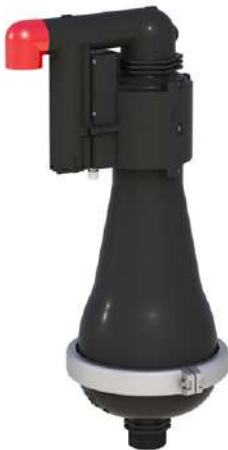
The ARISENSE smart air valve was installed with a manhole pit-level float switch sensor, enabling Wessex Water to know in real time if the manhole chamber of the air valve becomes flooded.

To overcome the communication issues of remote locations, an external antenna was discretely installed above the manhole cover, at a height of 5 cm.

The **D-025LNS-AS** DN80 (3") ARISENSE was specially specified with a non-slam feature to prevent surge in the event of rapid filling of the system, enabling the valve to operate under a wide range of system conditions.

Given the sensitive location of the ARISENSE smart air valve, a special low-pressure float and seals were specified, to ensure that the valve seals at 5 cm water column volume.
